Misinterpreted Engine Situation

Morrisville, NC

December 13, 1994

Engine self-recovery light
misinterpreted.

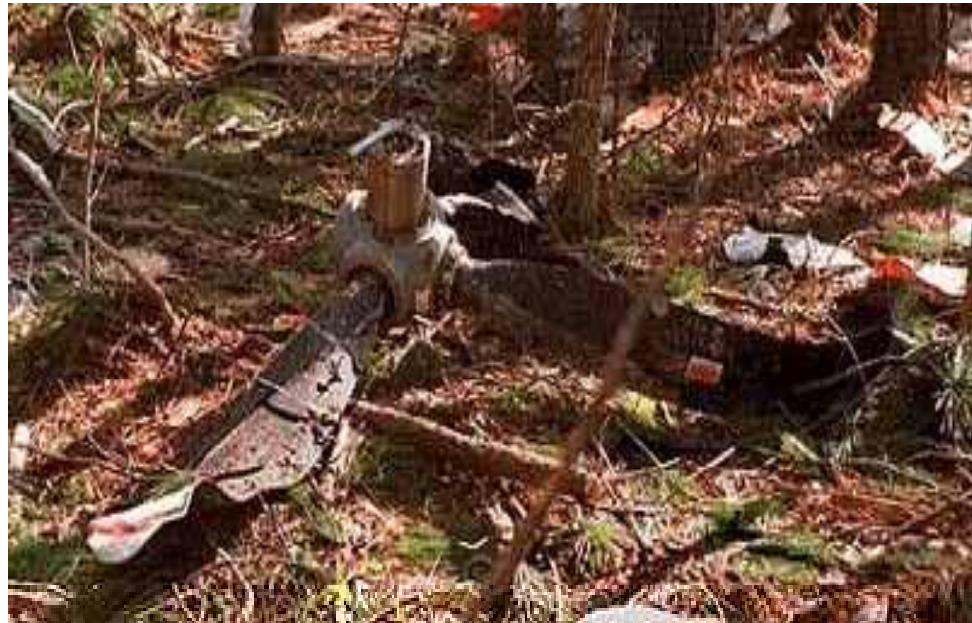
Control lost on attempted go-
around.

Fatal crash.

The aircraft crashed while executing an ILS approach into Raleigh-Durham. The captain misinterpreted a momentary ignition light to be an engine failure and did not crosscheck the other engine instruments. The aircraft stalled during attempted go-around from a single-engine approach even though the other engine was operating normally. The ground impact and post-crash fire destroyed the aircraft. There were 15 fatalities, including the 2 crewmembers. Thirteen additional passengers received serious injuries.

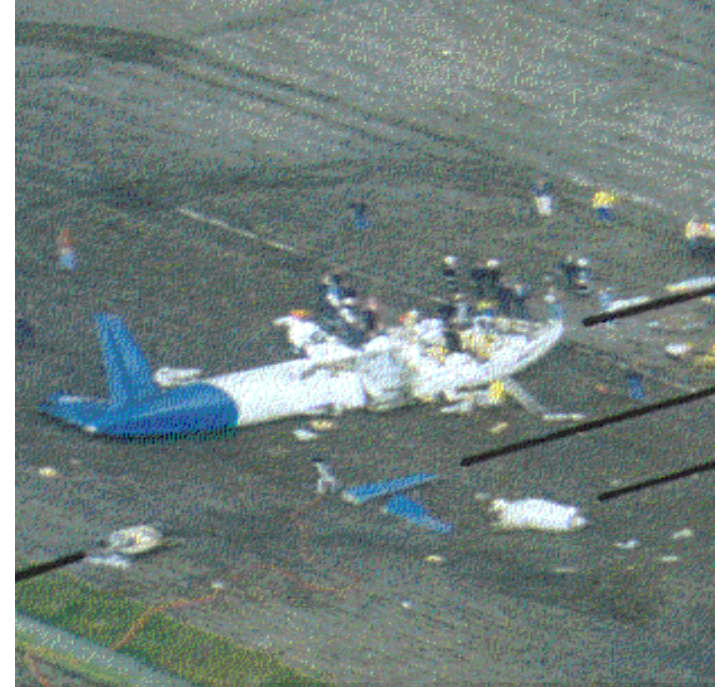
Commuter flight.

Attempted go-around below V_{MCA} .

3 fatalities; 9 serious injuries.

The pilot reduced power to flight idle on the right engine after observing a (false) low oil pressure light in cruise, and returned to Schiphol. The pilot did not feather the propeller. At an altitude of 45 ft, the crew determined the approach was not stabilized and declared a go-around. Airspeed was 110 kt, close to V_{MCA} (103 kts). The pilot used aileron input to combat the airplane yaw; no rudder input was used. Airspeed dropped, and the airplane rolled and yawed to the right until it crashed.

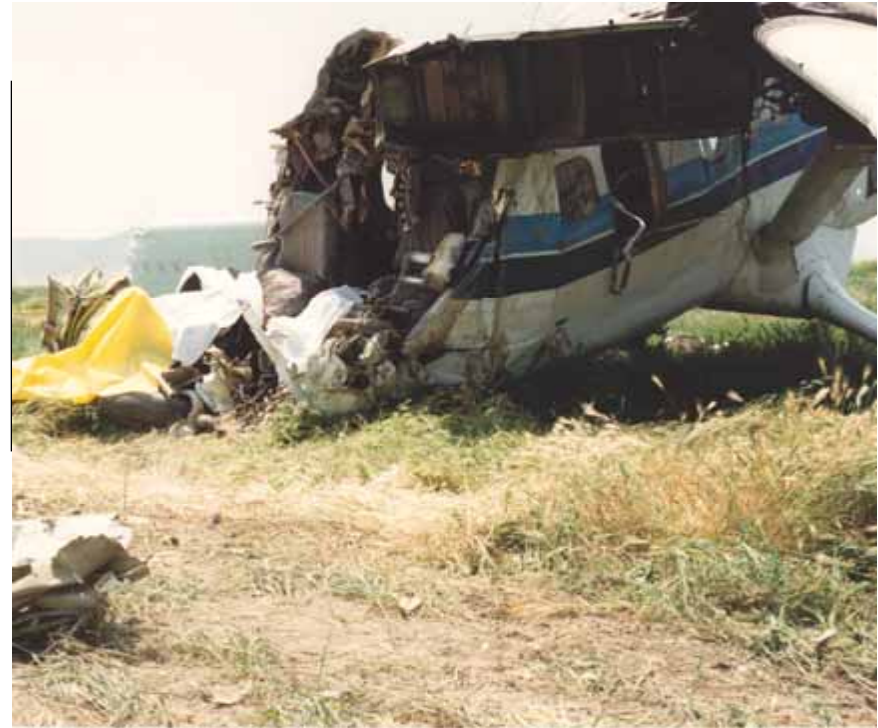
Inappropriate pilot action following engine failure during takeoff.

16 fatalities; 4 serious injures.

The No. 2 engine stopped at or immediately following liftoff on the second flight of the day. Eight gallons of water had mistakenly been pumped into the airplane's forward fuel tank prior to the occurrence flight. The low-time pilot did not correctly identify the malfunction and failed to "fly the airplane." None of the occupants, other than those in the cockpit (pilot and passenger) were wearing seatbelts. A number of aircraft airworthiness issues were also identified during the on-scene accident investigation. The autofeather and beta back-up systems were inoperative at the time of takeoff, contrary to Minimum Equipment List dispatch requirements.

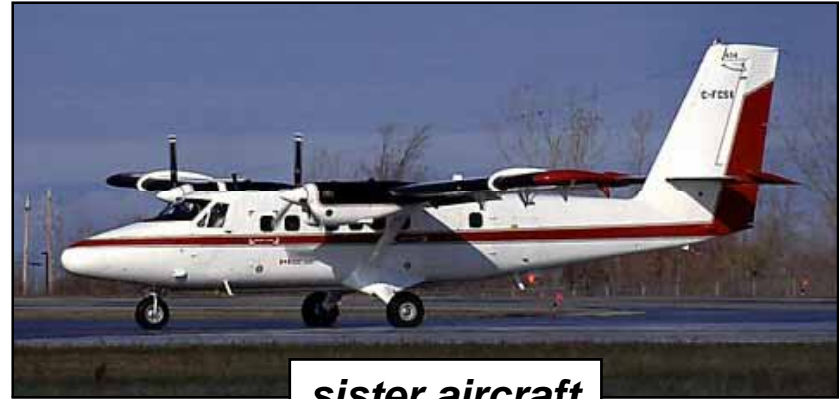
sister aircraft

Struck ground.

2 fatalities; 1 seriously injured.

The purpose of the flight was an instrument and proficiency check (IFC/PPC) on the left-seat pilot (PF) in VMC conditions. The check pilot was sitting in the right seat. Part of the check included a simulated overshoot at an altitude (greater than 3,000 ASL) with a simulated engine failure. Engine failures were simulated by shutting down the engine by pulling the fuel lever to the fully aft or to the "OFF" position. The PF was wearing instrument goggles, which simulated IMC conditions and also restricted visibility inside the cockpit. Therefore, the PF was not able to determine the manner in which the right engine was shut down. The third crew member reported seeing the right fuel lever in the OFF position upon feeling a yaw movement and observing that the right propeller was windmilling. Shortly after unusual cockpit activity, it became abnormally quiet, and the crew member observed that the left fuel lever was also in the OFF position. Approximately 600 ft AGL, the crew attempted a restart of the left engine by hitting the starter and placing the fuel lever in the fully forward or ON position. Time did not permit a complete start prior to the aircraft hitting the ground. A ground witness observed that right propeller was stopped and a stream of black smoke was coming from the left engine prior the aircraft striking the ground. The accident was not survivable for the front crew members. The flight deck was crushed back almost to the sloping bulkhead. The third crew member survived with serious injuries.

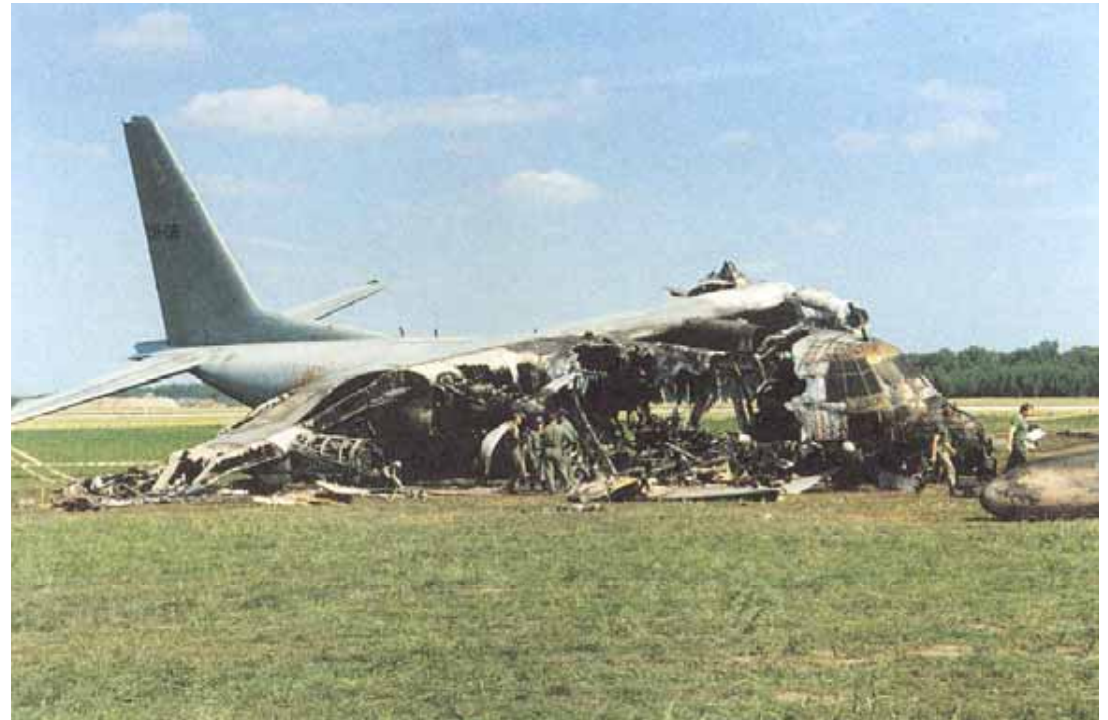
Bird ingestion on final approach.
Crashed during attempted go-around.

Engines 1 and 2 ingested birds at the runway threshold. The #3 engine was shut down by the crew; engines 1 and 2 were no longer operating. The crew decided to initiate a go-around at 100 kts; this was below the go-around speed of 134 kts. The airplane yawed and rolled slowly to the left, and then departed controlled flight.

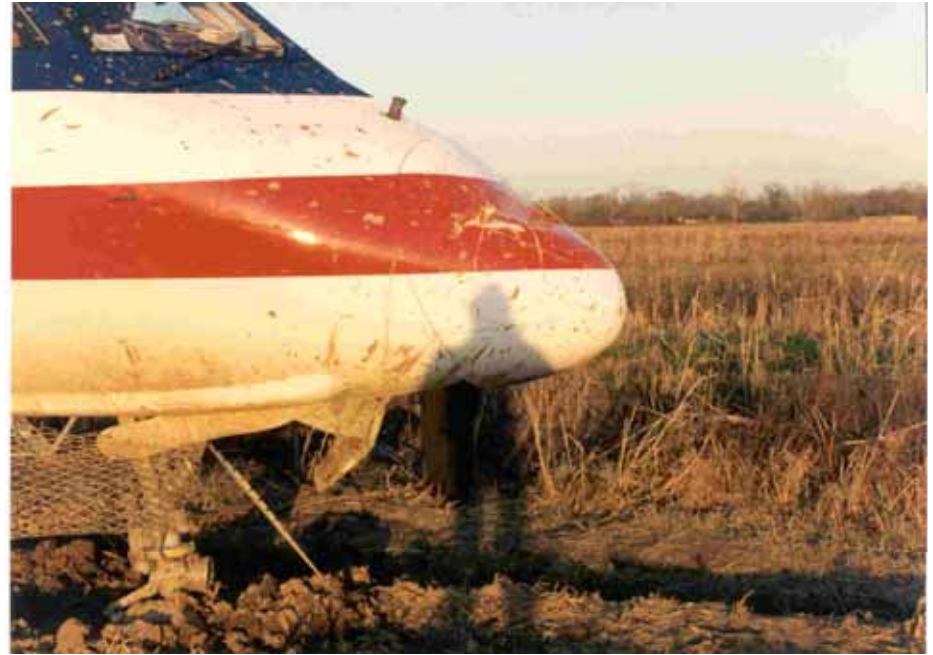
Dual engine propeller overspeed
and shutdown.
Forced landing, runway over-run.
No injuries.

During the descent, the airplane encountered turbulence. The DFDR shows that the power levers on both engines were then retarded to 15 degrees PLA, below flight idle. At this point, both propellers oversped, resulting in some power turbine damage. Since the engines were unable to produce torque, the pilot shut them both down and made an unpowered landing. The airplane overran the runway and sustained substantial damage.

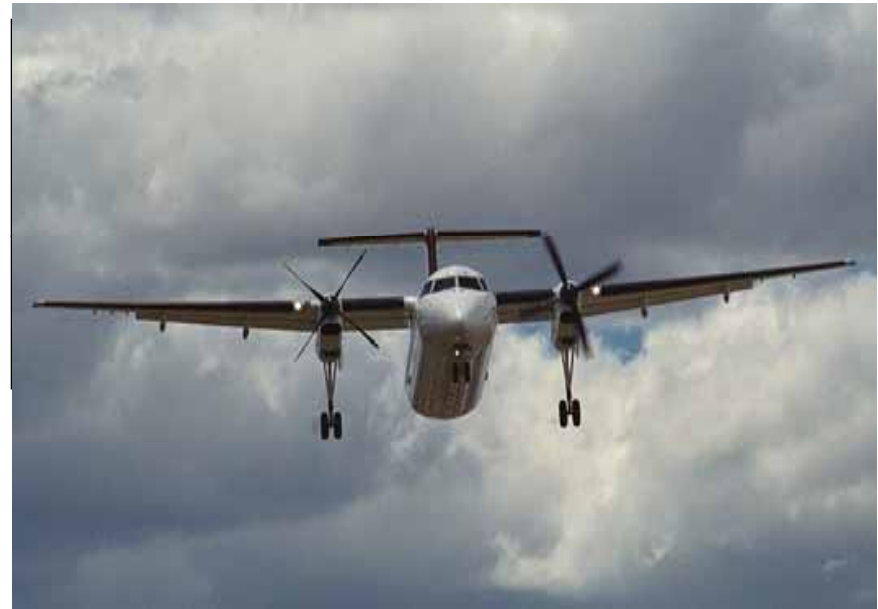
Aircraft performance issue due to inappropriate pilot action.

Airplane landed uneventfully.

The airplane's No. 2 engine experienced an uncommanded autofeather immediately after liftoff, with takeoff power selected. The flight crew inappropriately reduced power on both engines, in contradiction to AFM procedures. The reduction in engine power deselected the autofeather system and unfeathered the No. 2 propeller. The crew inappropriately responded by reselecting takeoff power on the No. 1 engine, and attempted to climb with idle power on the No. 2 engine and a windmilling, unfeathered propeller. Aircraft performance was significantly reduced by the flight crew's action.

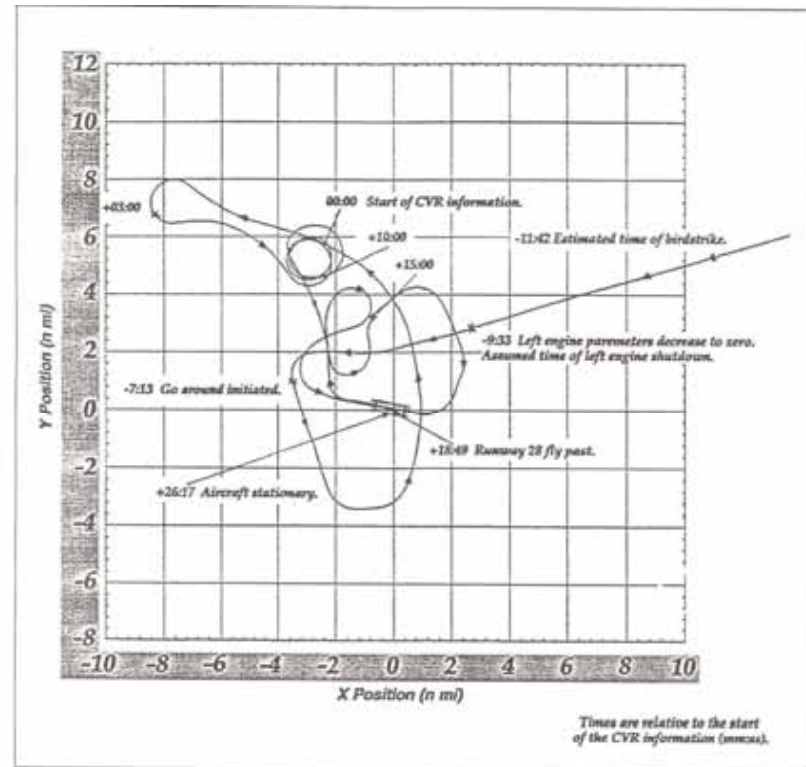
Figure 1. Derived ground track of VH-JSI

Loss of directional control
during single-engine landing.
Airplane departed runway.
No injuries.

The aircraft struck a 25-pound sea eagle during a V_{MO} descent into Broome, Australia. Due to an erroneous engine indication, the flight crew elected to shut down the No. 1 engine. Upon selecting landing gear down, the left main landing gear indicated an “unsafe” condition. The crew failed to notify Broome of the engine shutdown, ignored the alternate landing gear indication system (which indicated that the left MLG was down and locked), and continued for over 30 minutes to discuss the landing gear issue with ground personnel. The flight crew ultimately elected to perform a low-altitude, low-energy single-engine flypast of the control tower to ascertain left MLG position. Aircraft performance was significantly reduced during the single-engine flypast. The airplane ultimately landed and departed the runway due to inappropriate use of single-engine reverse thrust and braking.
