AIA / AECMA Project Report

Propulsion System Malfunction Plus Inappropriate Crew Response (PSM + ICR)

Volume 1

1 November 1998

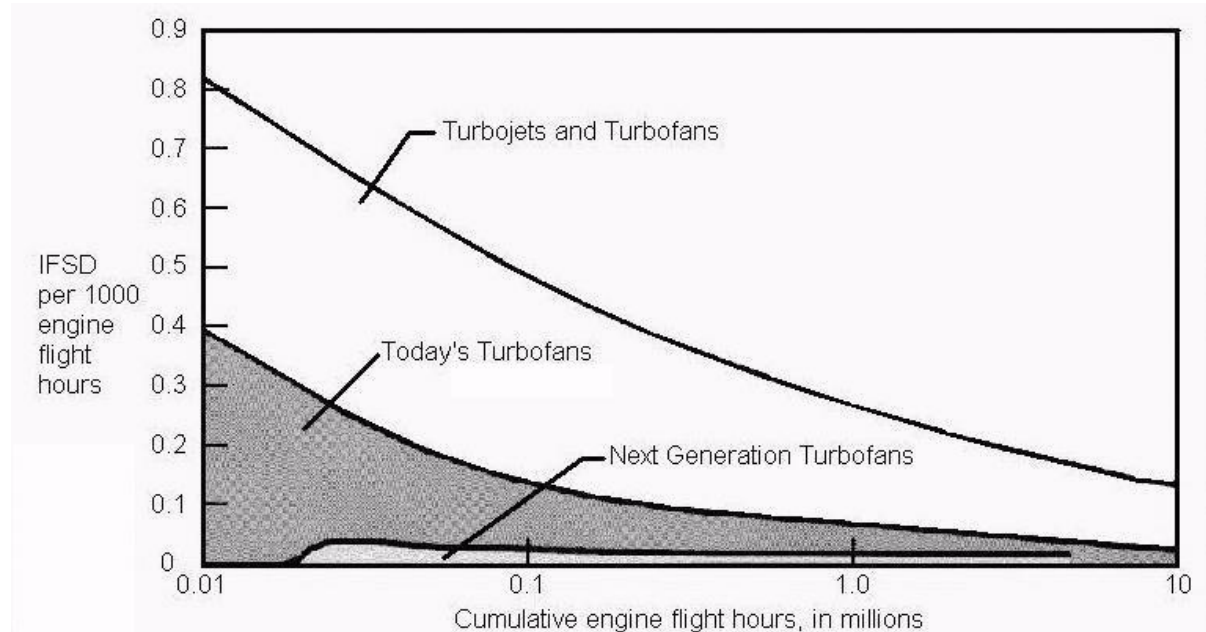
Figure 2.1 Summary of total Inflight Shutdown (IFSD) rates for turbojets and turbofan engines since 1958 shows a clear trend toward lower IFSD rates

During the last twenty years, there has been significant improvement in propulsion system reliability as shown in Figure 2.1. Despite the significant reduction in propulsion system malfunctions, the overall PSM+ICR accident/incident rate has remained essentially constant, suggesting that the likelihood of inappropriate crew response to the propulsion system malfunction has increased. Uncontained engine failures had previously been the dominant contributor to propulsion related turbofan and turboprop airplane accidents, but with the steady effort of the industry, uncontainments have been reduced. PSM+ICR is now the dominant contributor (25% of hull loss and fatal accidents over the past 5 years) to propulsion related turbofan and turboprop airplane accidents.

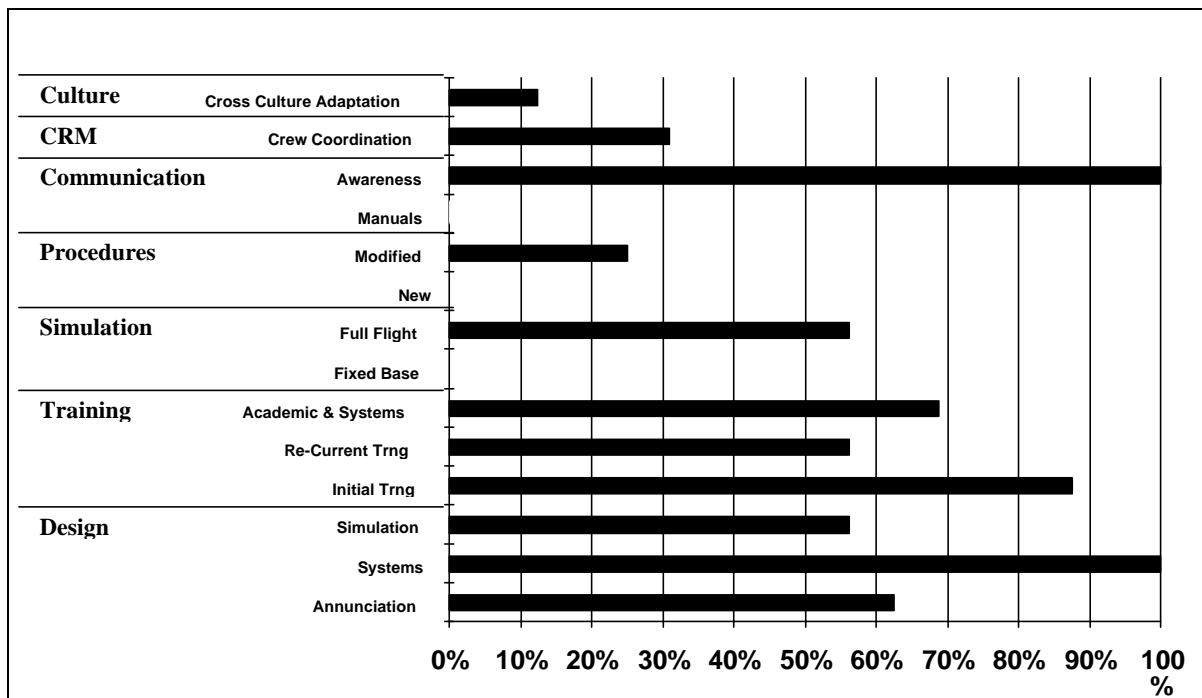
Figure 4.1.4.1 Potential Improvement Opportunities

The data analysis team considered each event in the database and determined by consensus what were the potential areas for improvement based on each event. These potentials were then tabulated and are presented as percentages in the table below.

The areas with greatest potential improvement opportunities were those of “awareness” and “systems design”. Providing “awareness” information to flight crews on these types of events and the symptoms that the crew faced was judged by the team to be beneficial in all cases. Further, the team realized that reduction in the frequency of the initiating propulsion system malfunction/failures would also be effective (reduce the rate directly). However, the data team noted that such improvements (reducing the initiating propulsion system malfunction/failure rate) would be difficult to achieve, at least in the near term.

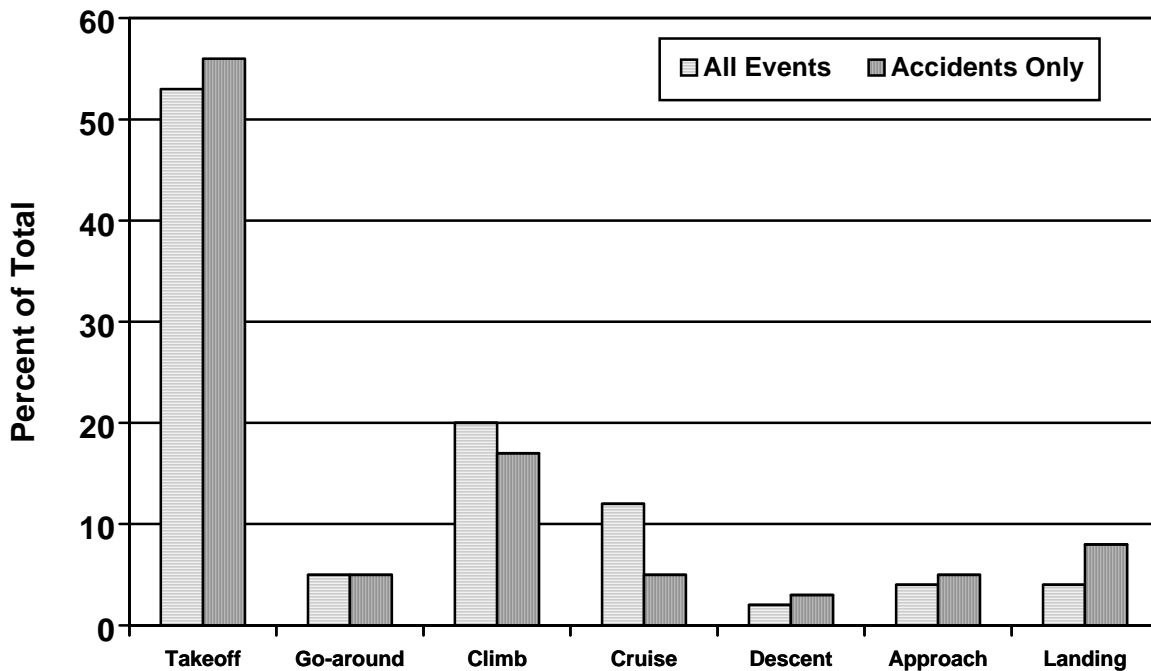
Figure 4.1.5 Phase of flight distribution summary

The figure 4.1.5 below depicts the percentage of turbofan events as a function of flight phase. The majority of events, over 70% occur during the takeoff and climb phase of flight.

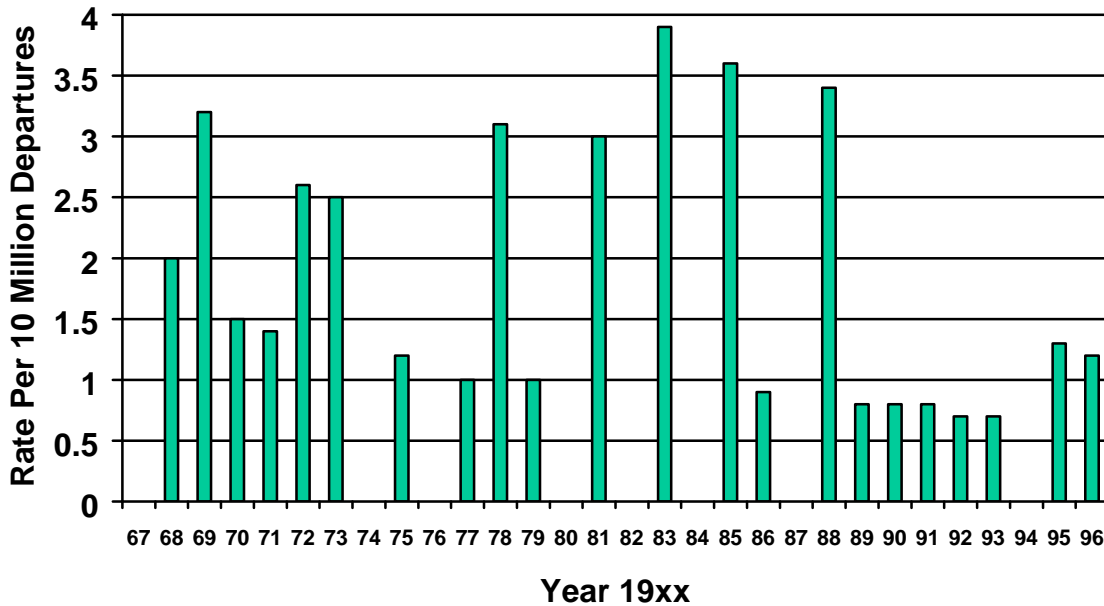
Figure 4.1.6 Annual accident rate trend with time - Hull loss and substantial damage

The figure 4.1.6 below depicts the PSM+ICR annual accident rate per 10 million departures for the turbofan events. This rate was calculated using the number of hull loss and substantial damage type accidents per year divided by the total yearly commercial fleet airplane departures. The annual accident rate for PSM+ICR appears to be constant.

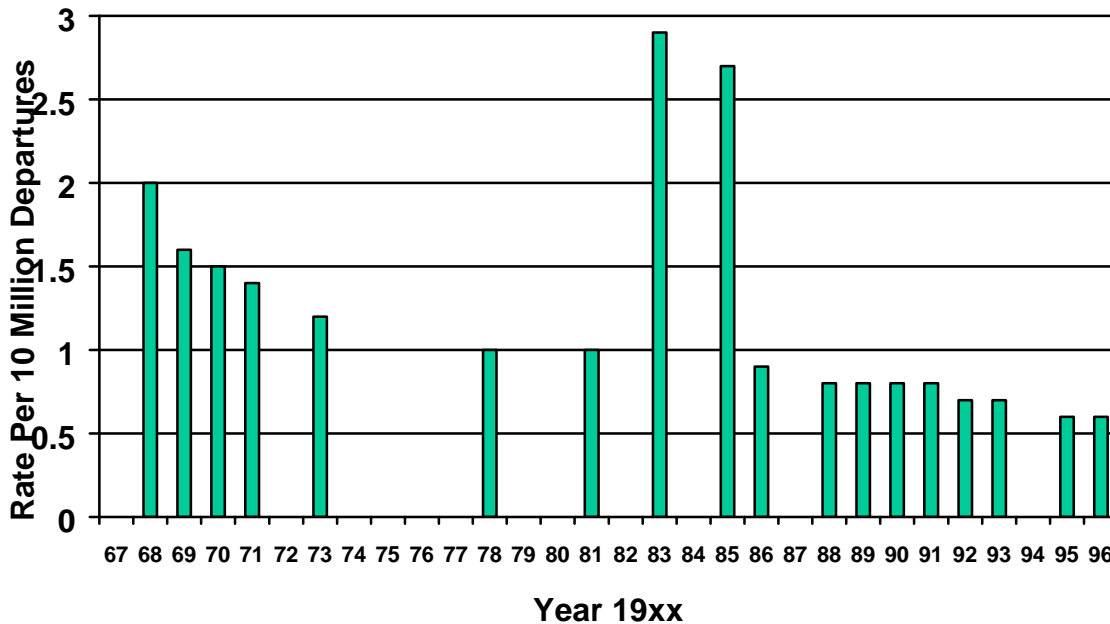
Figure 4.1.6 Annual accident rate trend with time - Hull loss only

The figure below depicts the PSM+ICR annual Hull Loss-only accident rate per 10 million departures for the turbofan events. This rate was calculated using the total number of hull loss accidents per year divided by total yearly commercial fleet airplane departures. The annual accident rate for PSM+ICR appears to be basically constant.

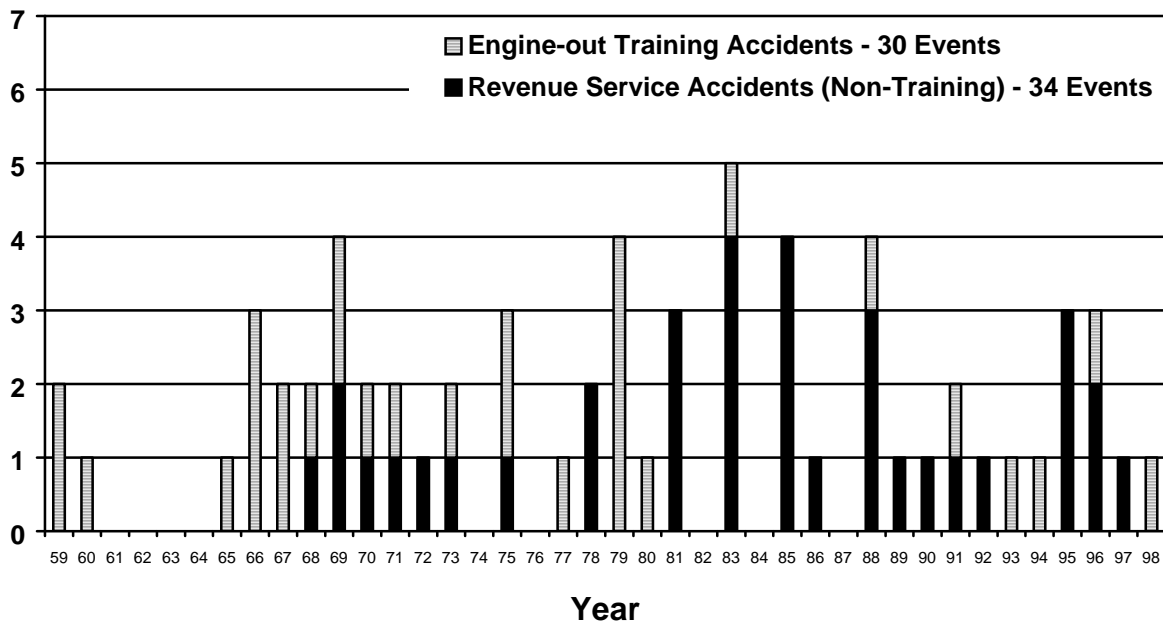
ure 4.1.8 Comparison of PSM+ICR revenue service events versus simulated engine-out crew training events

A review of the historical accident record for western-built turbofan airplanes involving training accidents where either single or multiple engines were reduced to minimum thrust setting (simulated engine-out conditions) was conducted to examine relative frequency, phase of flight, and geographical location of the events. The following chart depicts the number of simulated engine-out training related accidents (Substantial Damage, Hull Loss, and Fatal) in comparison to the PSM+ICR accidents since the beginning of commercial jet transport service.

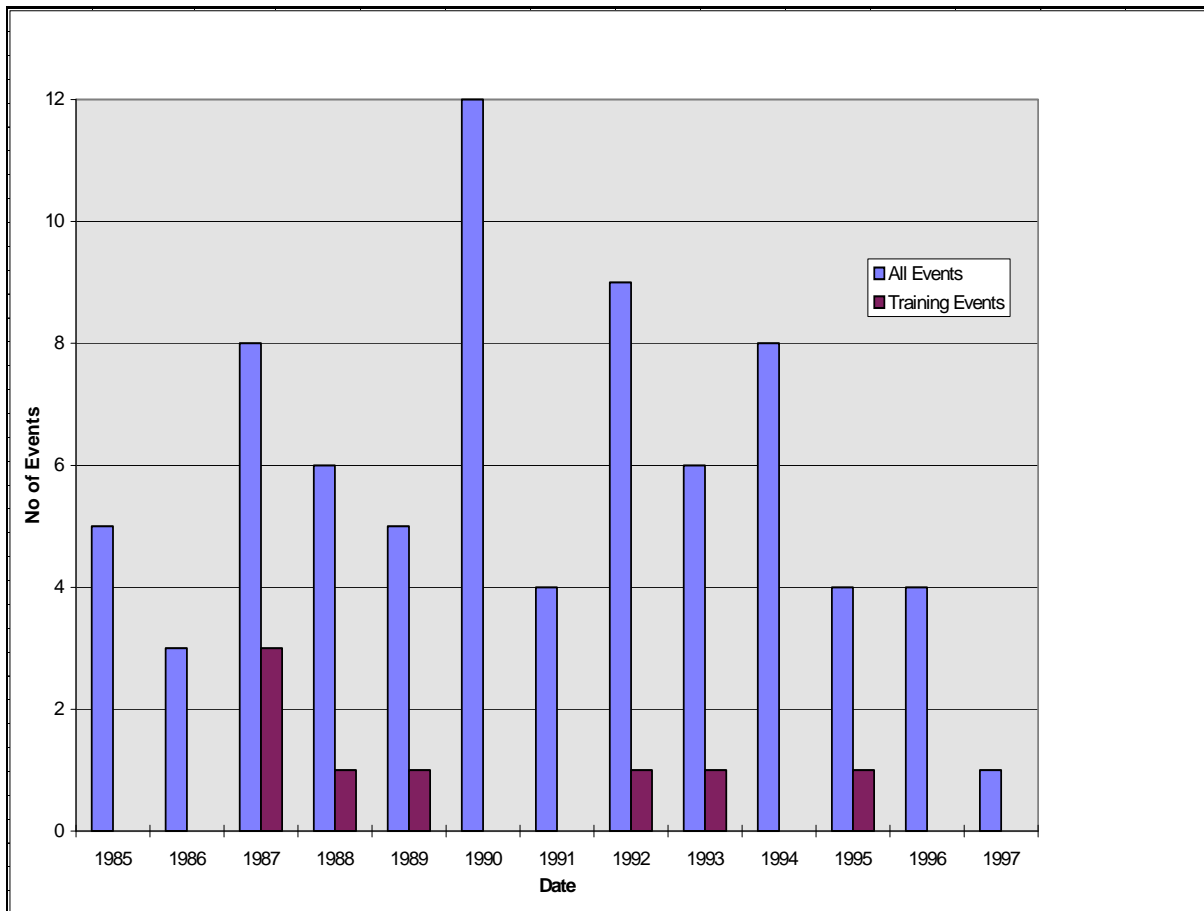
Figure 4.2.1 Chronological Distribution of Turboprop PSM+ICR Events since 1985

The annual numbers of turboprop PSM+ICR events since 1985 are shown in Figure 4.2.1 below. It will be seen that there is no recognizable upward or downward trend in the annual numbers. However, it does show that these events continue to occur at a rate of 6 ± 3 events per year, indicating that action is required if this rate is to be reduced. The data for 1997 are only partially complete.

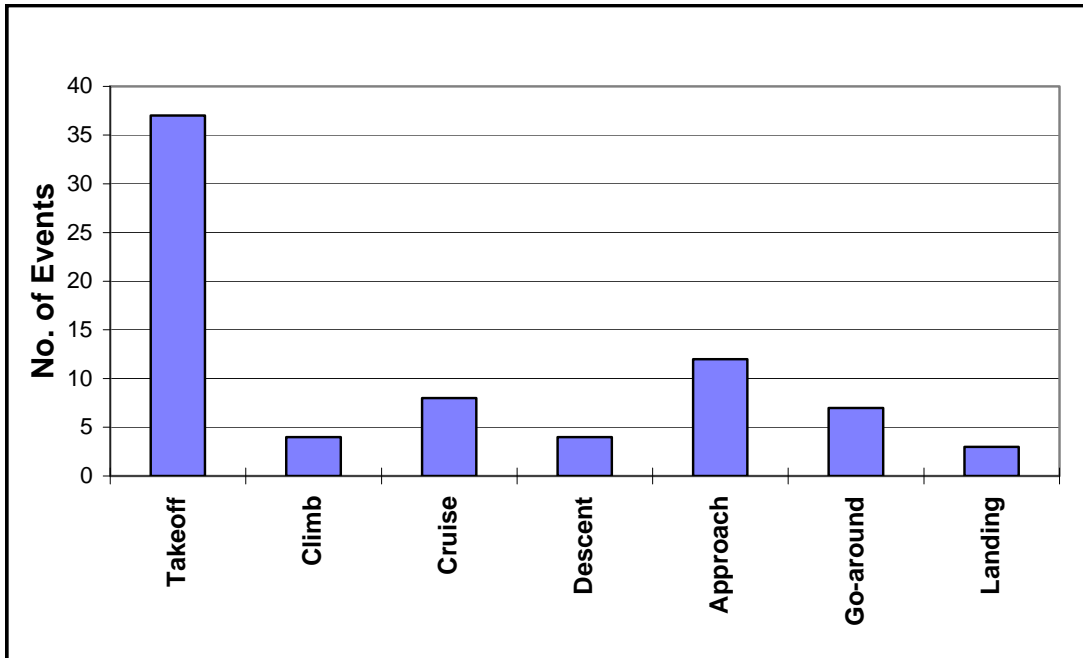
Figure 4.2.2 All events, by phase of flight

The number of propulsion system malfunction events which occurred during a particular phase of flight is shown in Fig 4.2.2. The phases of flight are defined in Section 3.0 of this report. The dominant phase of flight for all turboprop propulsion system malfunctions is Takeoff - this

accounts for half of the accidents. The next highest flight phase in the rankings was Approach, where there were 12 events (16% of the total).

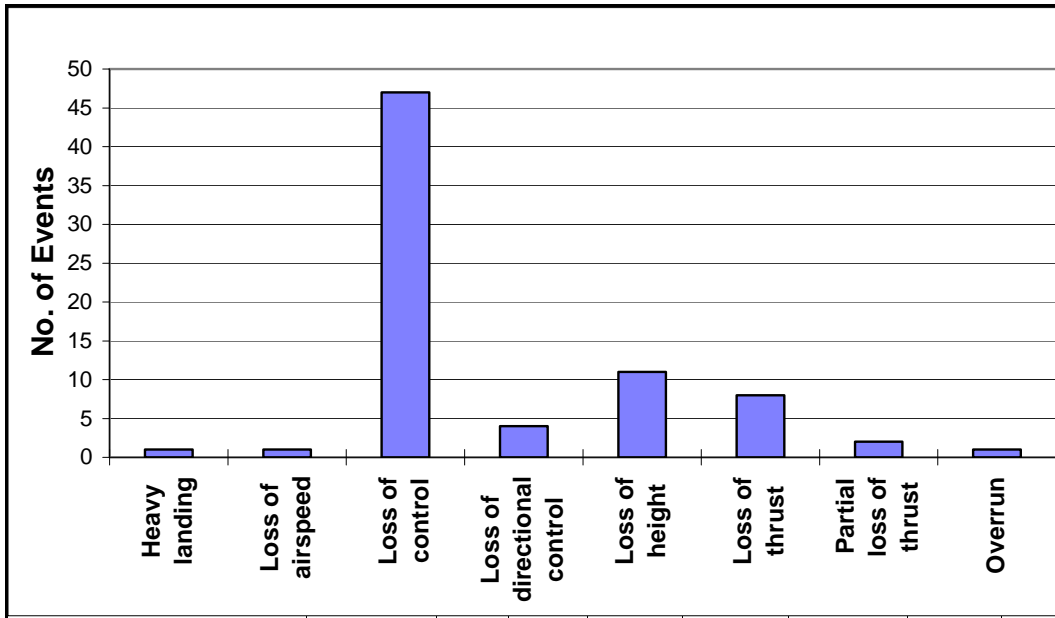
Figure 4.2.3 All events, by category

The accidents were categorized and the results are plotted on Figure 4.2.3 below. The dominant event category is Loss of Control, accounting for 63% of all events.

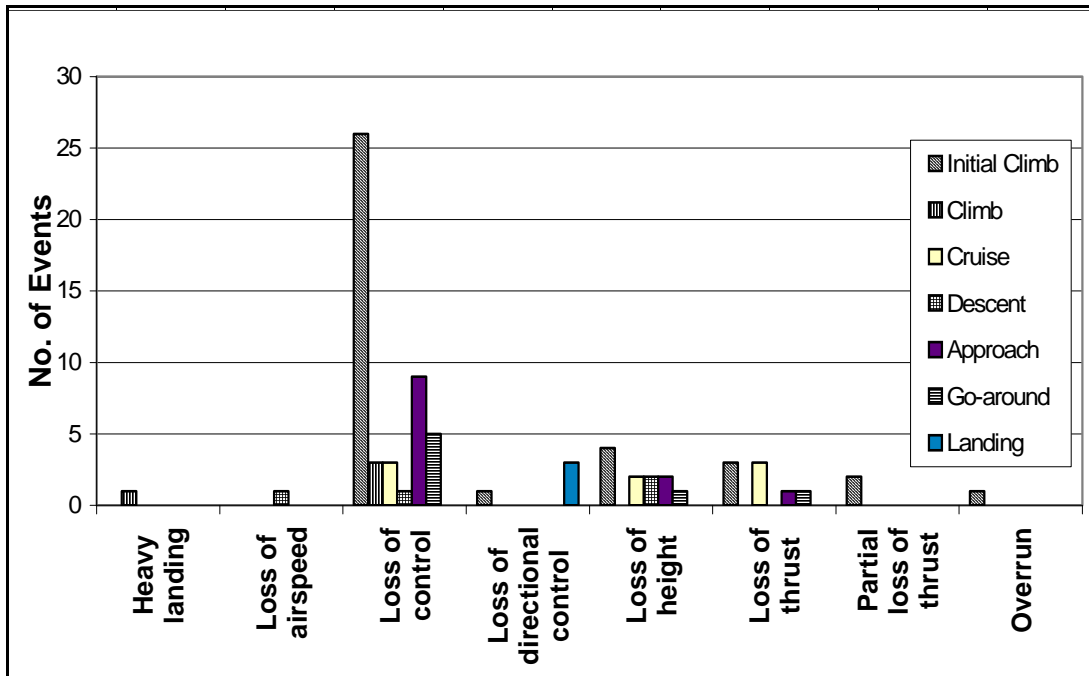
Figure 4.2.4 All events, by category and phase of flight

Figures 4.2.2 and 4.2.3 show clearly that Takeoff and Loss of Control individually dominate their respective analyses. Figure 4.2.4 shows that these two classifications strongly coincide. A correlation of the data by flight phase and event category shows that 70% of the “powerplant malfunction during takeoff” events led to loss of control, either immediately (22 events) or on the subsequent approach to re-land (4 events). Or, put another way, 55% of the “loss of control” events occurred during the takeoff phase of flight.

It is concluded that the overwhelming majority of turboprop accidents resulting from powerplant malfunctions occur during the takeoff phase of flight and are due to the loss of control of the airplane.

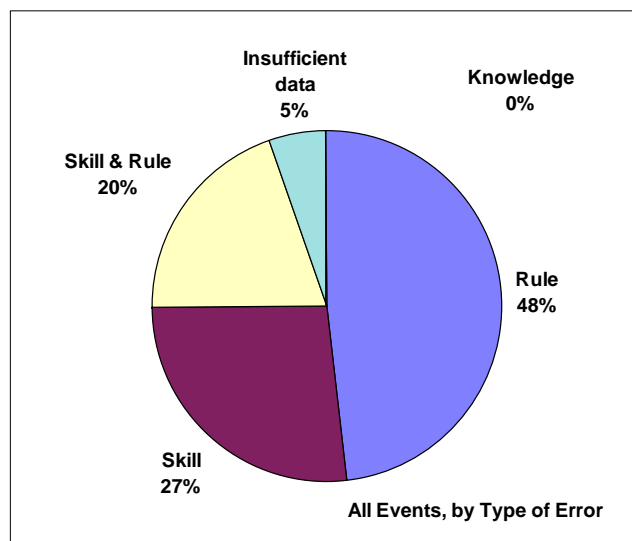
Figure 4.2.5 All events, by type of error

Each accident was evaluated to determine the specific error type associated with the inappropriate crew response. However, the assessment was based on the opinions of the experts involved. The error types are those defined in Section 3.0 of this report. Figure 4.2.5 below shows the distribution of error types.

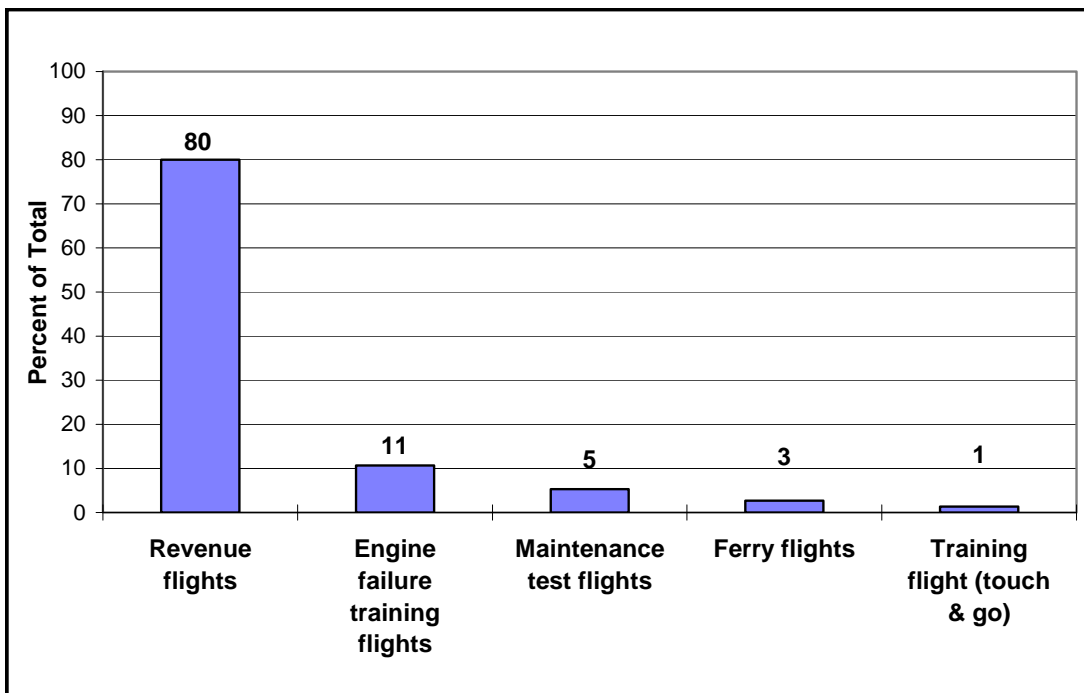
Figure 4.2.6 All events, by type of flight

The percentage of accidents for a given type of flight is shown at Fig 4.2.6. Revenue flights accounted for 80% of the events. As discussed previously, the data does not support a detailed breakdown between 14 CFR Part 121 and other operations.

A disproportionately large number of events (17%) occurred during training or test flights.

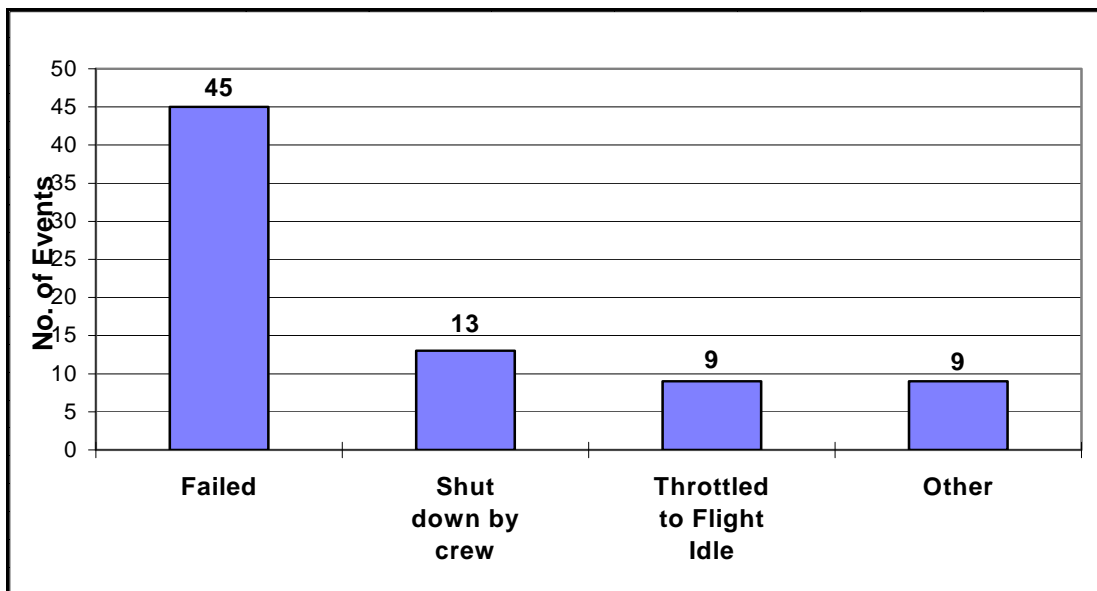
Figure 4.2.7 All events, by type of powerplant malfunction

The types of powerplant malfunction identified as the initiating event are shown in Figure 4.2.7. Propulsion system failures resulting in an uncommanded total power loss was the dominant category. Turboprop engines seldom experience compressor stall/surge. This is significantly different from the situation on turbofans. Discussion with engine manufacturers concluded that one reason for this difference is that most turboprop engines (and some small turbofan engines) have a centrifugal stage in the compressor and hence are more tolerant to instability.

power loss/torque fluctuations etc.) and the crew then shut down that engine, or where one engine malfunctioned and the other (wrong) engine was then shut down. The distinction between “shut down by crew” and “failed” is that in the “failed” events the engine suffered a total power loss prior to any crew intervention.

There were 6 of the 13 “shut down by crew” events where the pilot shut down the wrong engine - three of which were on training flights where the instructor had deliberately throttled one engine and the student then shut down the wrong engine. Accidents where the engine was not shut down, but maintained at flight idle, identified a category where there could have been a serious misunderstanding and lack of knowledge of turboprop operations. When an engine is at idle the unfeathered propeller can give negative thrust, which, particularly at low airspeed, can result in a thrust asymmetry beyond that for which the airplane was certificated. Events in this category included training and deliberate “idle” selection by the crew. Each of these categories will be discussed later.

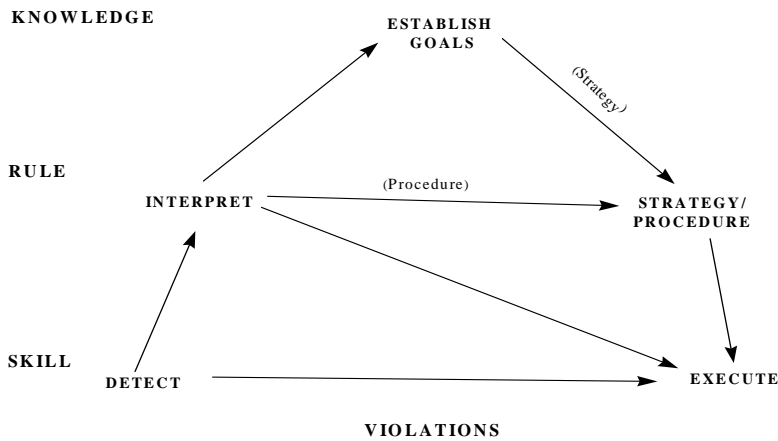
Figure 8.4 Classification of Errors in the Presence of Propulsion System Malfunctions Which Lead to Inappropriate Crew Responses⁵

The rationale for using both the “strategy” and “procedure” terms is illustrated in Figure 8.4 and Figure 1 Volume 2, Appendix 14. The term “procedure” is used to refer to those situations where a formal, written procedure or widely accepted “best practice” exists, or should exist, for dealing with a PSM which has been appropriately identified. The term “strategy” is used to infer the plan of action selected by a crew when no formal procedure or best practice existed or, at least, was known to the crew. Implementation of an inappropriate strategy would be classified as a knowledge-based error, whereas selecting the wrong procedure to use with a particular PSM would be a rule-based error. For the purpose of supporting Workshop recommendations, the error classification model breaks down the types of errors leading to inappropriate crew response in the Strategy/Procedure category well beyond the rule-based/knowledge-based error classification. By doing so, the relationship between the error classification data and the recommendations of the Workshop are much clearer.

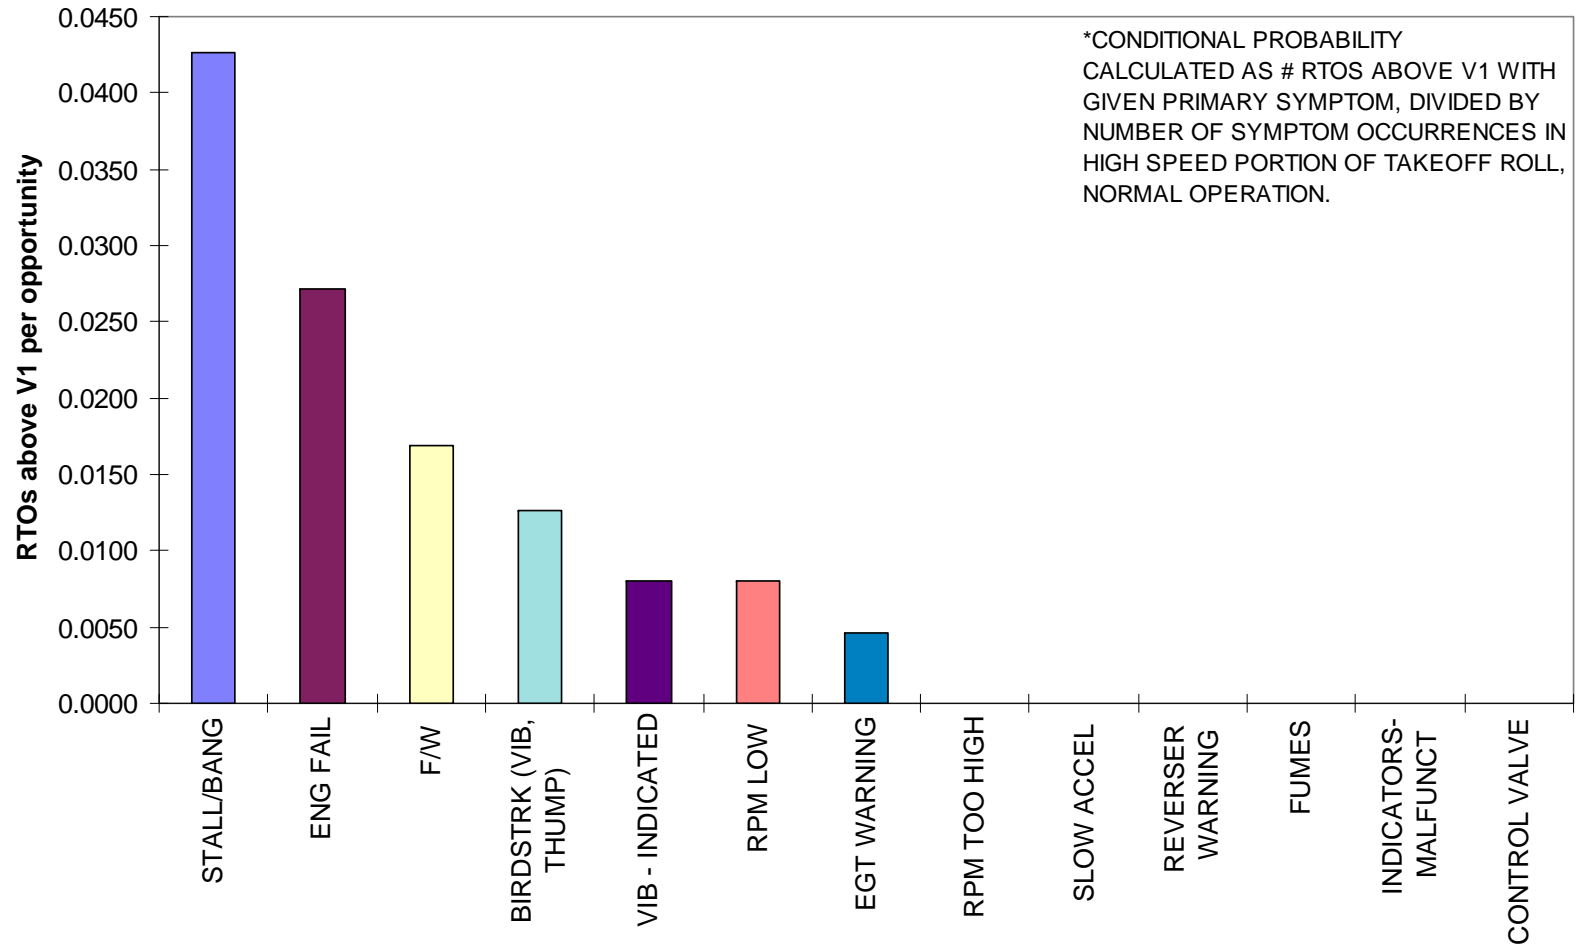
CONDITIONAL PROBABILITY* OF RTO ABOVE V1, BY SYMPTOM FOR A HIGH BYPASS TURBOFAN FLEET

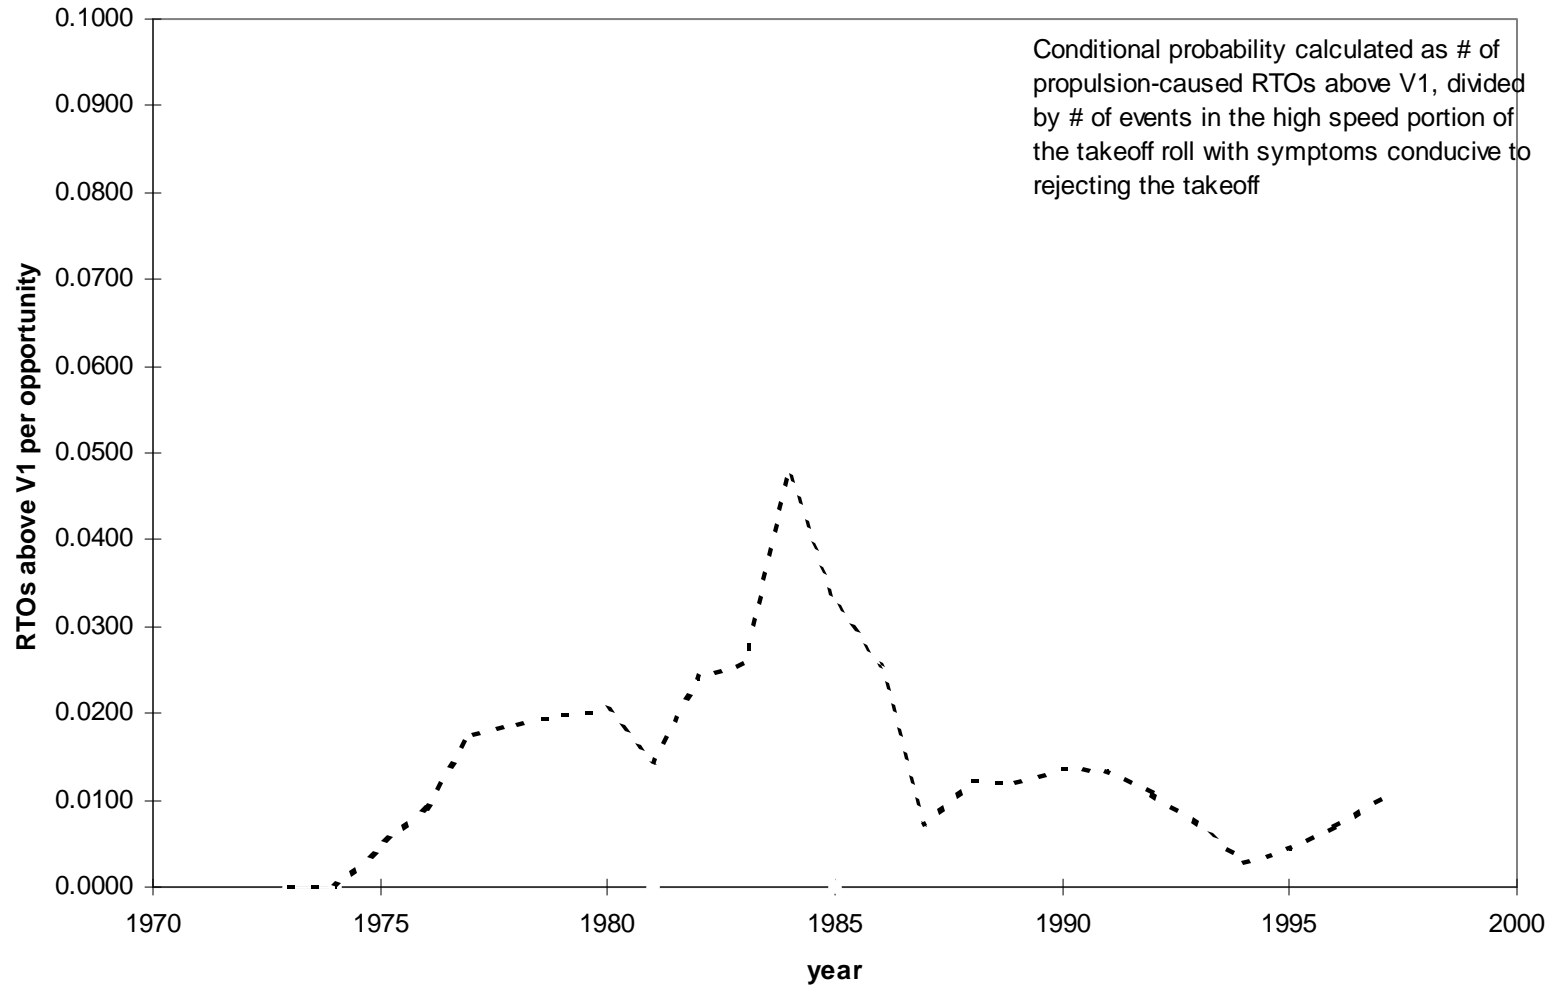
Conditional Probability* of RTO above V1 showing 3 year average

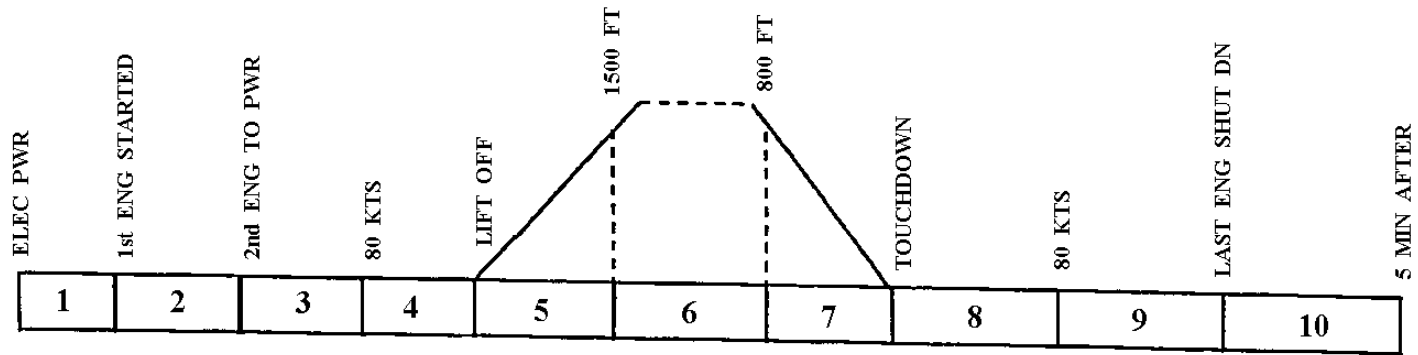
Airbus Alert Inhibit Points

ENGINE FAILURE INDICATIONS FOR AIRBUS FLEET

(3 = Master Warning, 2 = Master Caution, 1 = No Master Caution, No = Nothing)

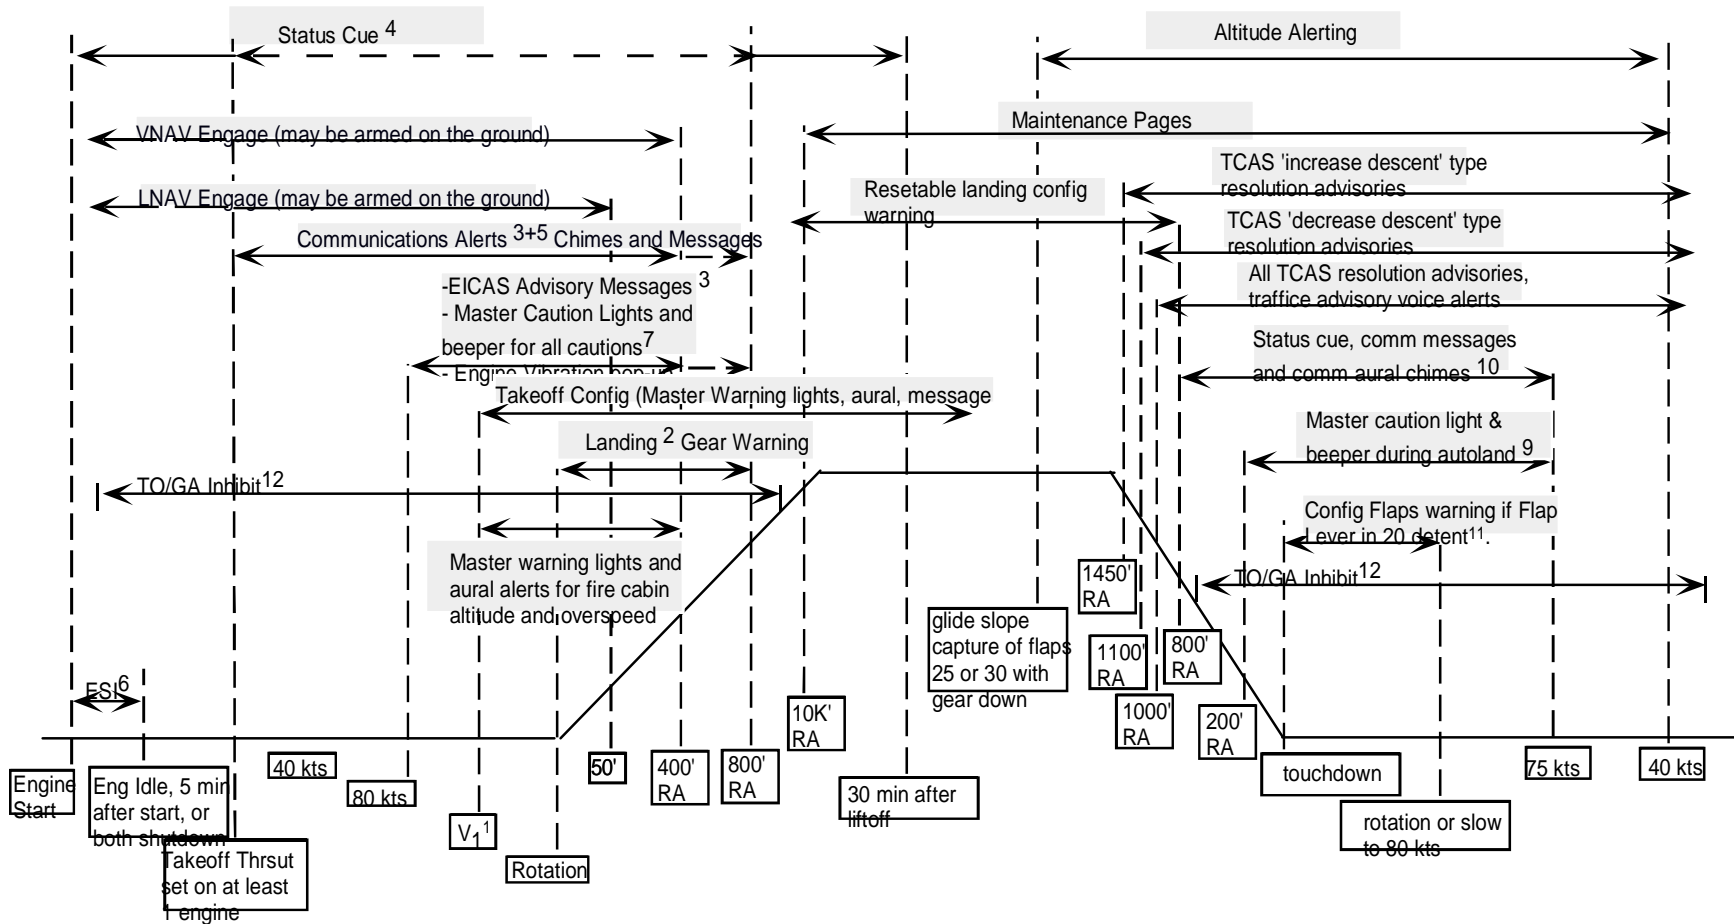
Boeing Alert Inhibit Points.

1. Rotation through 5°pitch angle used for default if CAS not available: 80 kts if V1 not available.
 2. Resetable Landing Gear Warning inhibit ends at 800' or 140 sec, whichever occurs first.

3. Inhibit option: to 800' or 30 sec after rotation.
 4. Basic: any on-ground engine start to 30 min after liftoff or any eng shutdown after ESI. Option from takeoff thrust to 800' or 30 sec after rotation or groundspeed < 75 knot

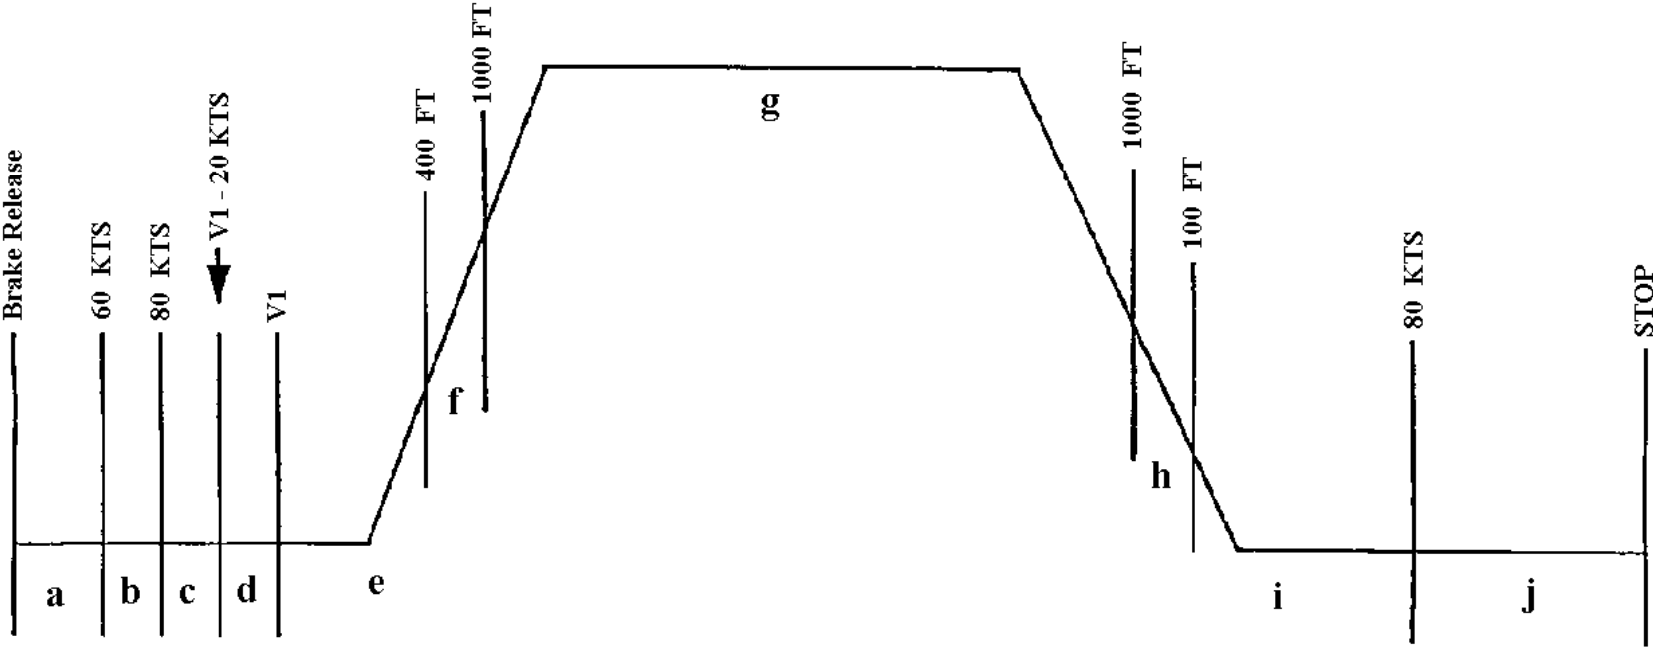
Douglas Alert Inhibit Points

ENGINE FAILURE INDICATIONS FOR DAC AIRCRAFT

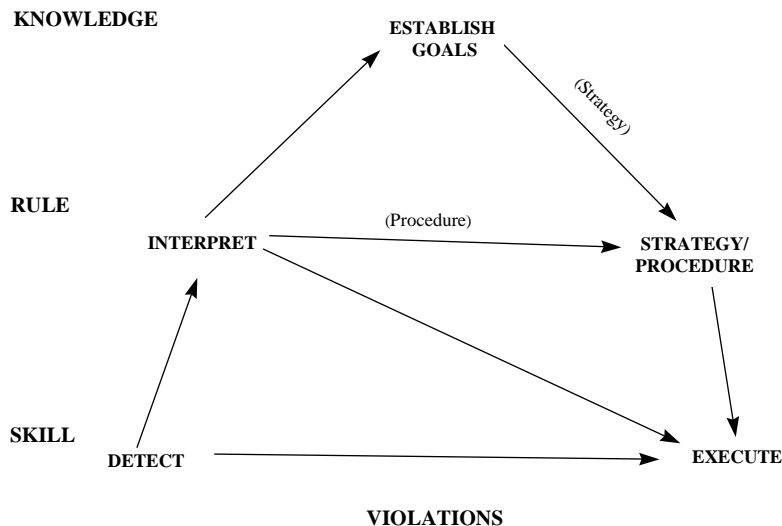
The model developed is illustrated below in Figure 1. The primary error categories are represented by the terms located around an “inverted U-shaped function”. The higher-level classifications of skill-, rule-, and knowledge-based errors are shown in approximate relationship to the primary categories. The mapping of these relationships, however, is only approximate as can be seen by reviewing the detailed classification of errors as shown in the second major section of this appendix. Sub-categories within each of the primary error categories were also developed to provide for a finer-grained analysis which could support more detailed recommendations. The Turbofan-DC&ATG Summary Database contains accident/incident events which occurred between 1968 and 1996. References to time frame (early, middle, late) are made within this range without fixed boundaries. However, the time frames the terms refer to are roughly “early” (late ‘60s and ‘70s), “middle” (‘80s), and “late” (‘90s).

Figure 1. Classification of Errors in the Presence of Propulsion System Malfunctions Which Lead to Inappropriate Crew Responses¹⁴

The number of sub-categories under each of the primary categories varies. The objective was to develop meaningful breakdowns in the data which could be used to support recommendations. Most of the sub-categories contain at least two additional groupings of the error data. Since the model is a work in progress, a few sub-categories were retained which have no event-driven error data as yet.

The attached material is an attempt to classify cognitive errors based on analysis of the Turbofan Summary Database in such a way as to support the development of detailed recommendations on solutions for addressing PSM+ICR issues. The “model” used as adapted from Rasmussen (1982) is shown in Figure 1. It illustrates the now ubiquitous error classification levels of skill-based, rule-based, and knowledge-based errors as well as Rasmussen’s inverted U components. The error categories identified within this context include only the basic cognitive functions. The transitions between functions are illustrated with arrows. Application of the model to accident/incident data has resulted in the identification of varying numbers of specific error types (sub-categories) within the basic categories. Additional error types may be defined and refinement of existing definition wording can be expected also with any future work on the model.
